Intel® Firmware Support Package (Intel® FSP) for with Intel® Atom™ processor E3900 product family (formerly Apollo Lake), MR10

Release Notes

January 2022

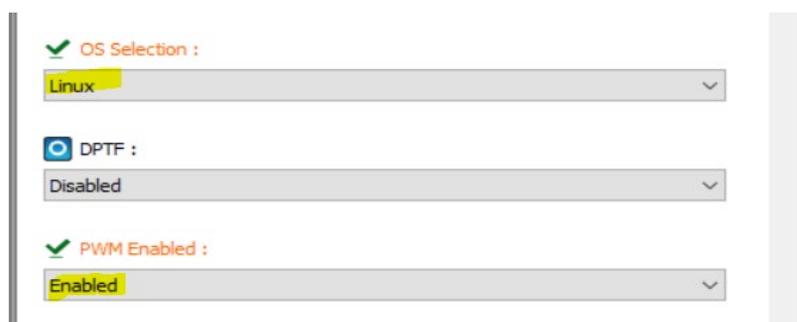
- PWM controller CPU fan is not spinning with default MR4 CB Release. Required to set UPD's using BCT tool as show below in order to CPU fan to spin.

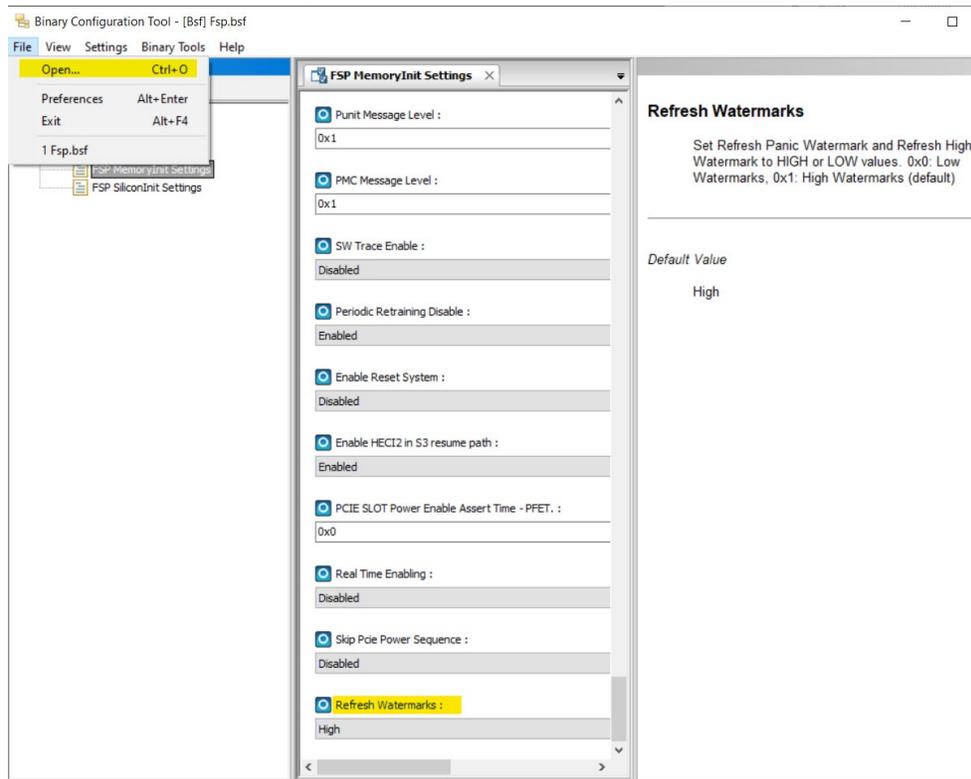
1. See [9.0 Configuration](#) to get BCT tools.
2. Open Fsp.bsfc in BCT tools by clicking on **File > Open**.

3. Check the value in the dropdown config of **'Refresh Watermark'** in FSP_M settings is High and Low.
4. If yes, it is MR10.

The Intel® FSP for MR10 and MR9 can be differentiated by reading the config using BCT tools since MR10 contains features that are not included in MR9.
